Affinity Water

Bedmond, Hertfordshire

MULTISCAN, AQUASCAN & AQUASCOPE join forces to pinpoint a quiet leak on a plastic supply pipe

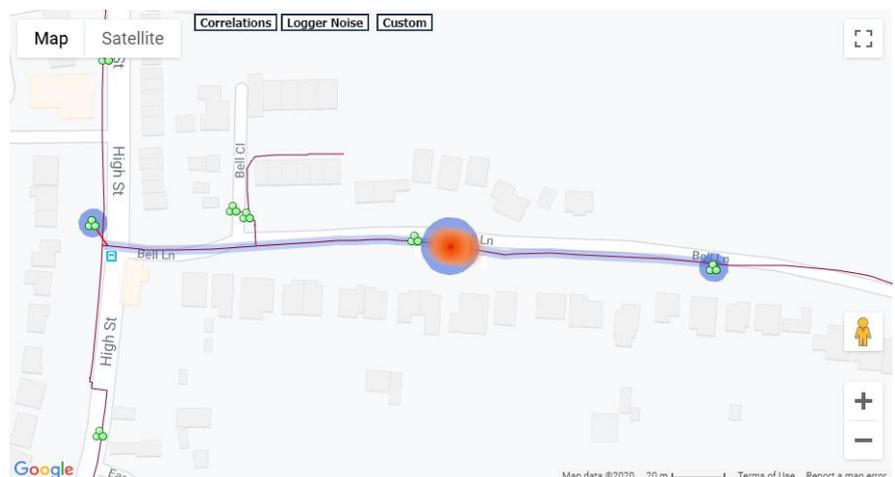
MULTISCANs (or the 'super loggers' as this team affectionately call them) were deployed in the area for an overnight read to get a better understanding of what might be happening when the pressures were higher and the background noise lessened. The results were very positive, as Figure 1 below shows.

Figure 1 - MULTISCAN point of interest

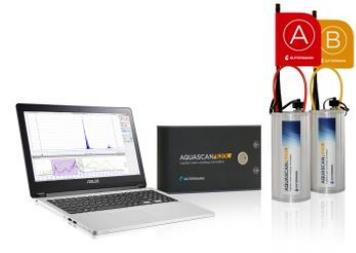
The AQUASCAN 620 Laptop Correlator was now utilised to correlate over the same section of pipe on Bell Lane that the MULTISCAN sensors had produced the area of interest.

Figure 2 - AQUASCAN 620L Correlator

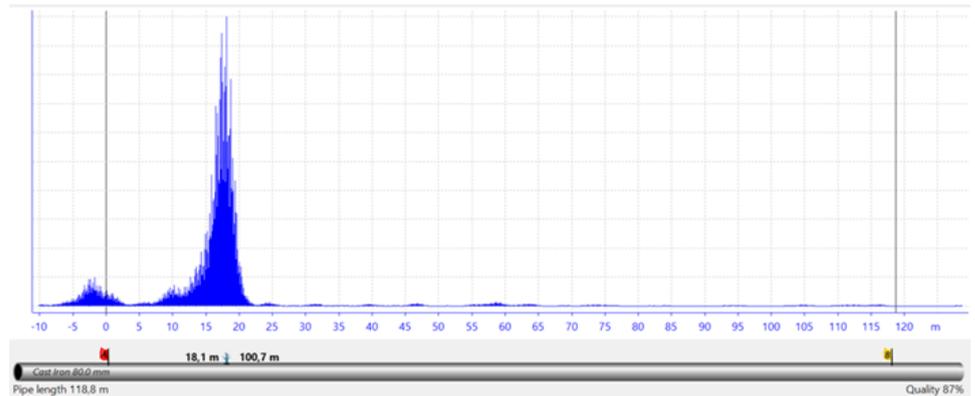
The result was a very good peak in a position that corroborated the MULTISCAN result.

Figure 3 - Correlation graph - Point of interest verified with AQ620L

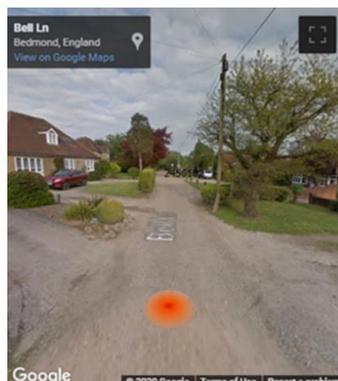
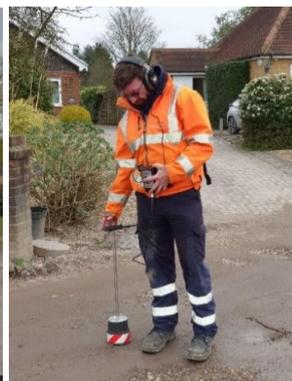
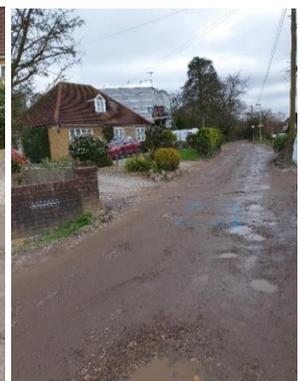
Figure 4 - AQUASCOPE 3 Ground Microphone

The AQUASCOPE 3 ground microphone was now utilised to pinpoint the leak. Top noise was deciphered from background noise by adjusting the filter range on the AQUASCOPE. The leak position was marked up in blue paint (position matched the one produced by MULTISCAN).

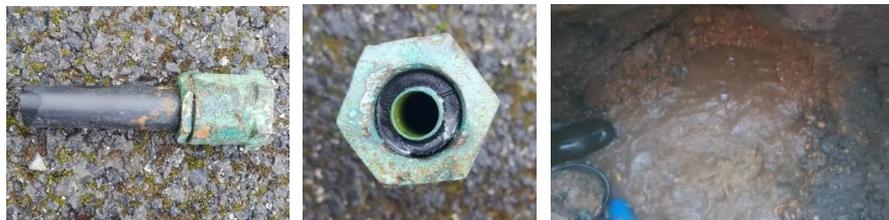
Excavation revealed a leak on a communication pipe at the location indicated by the Gutermann devices. The pipe was made of black poly, which is notoriously difficult to find leaks on due to its poor sound propagation. This leak had clearly been going for a while as it was finding its way out of the ground over 100m away on the High Street. Since the repair, this water has dried up and stopped showing.

Figure 5 - Excavation reveals leak on plastic communication pipe
